CARBIT[®]

Carbit in the mix...

Infrared ovens force-cure
industrial coatings

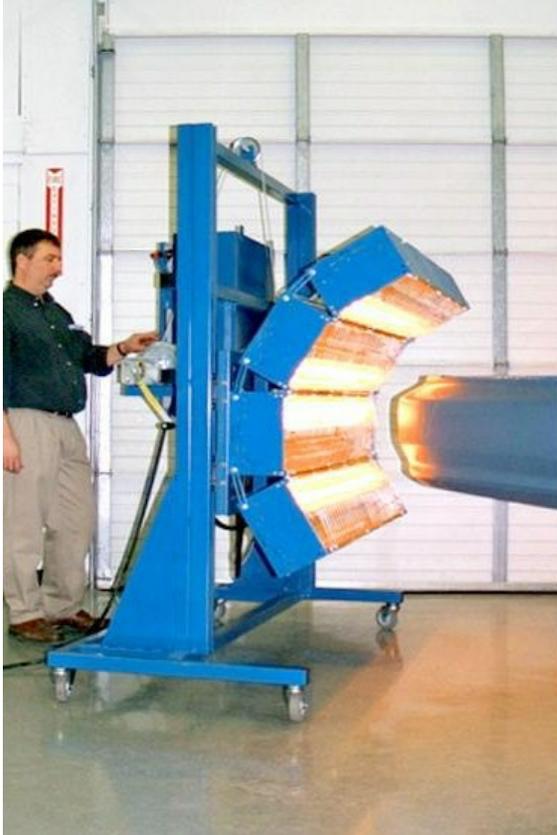
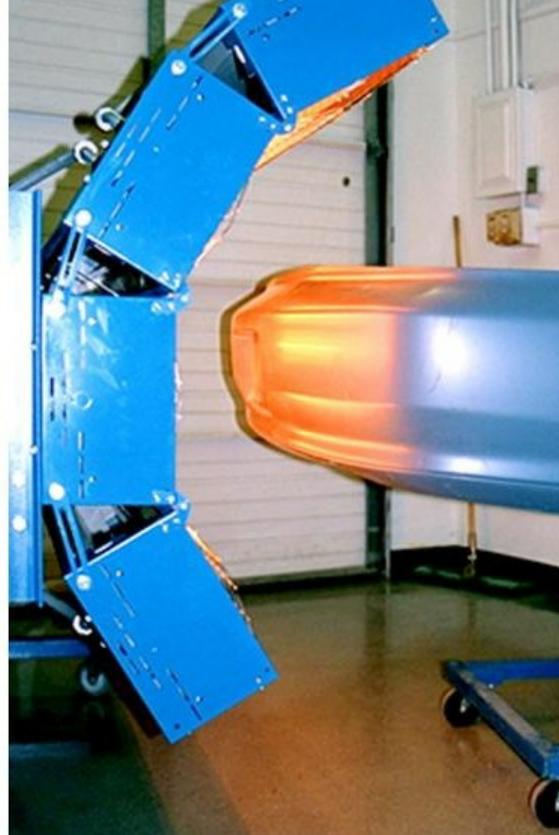
Paint, pack and ship the same day is a dream that has become a reality. Low VOC, water based acrylics are ready to handle and pack in minutes with a just a little heat - 5 minutes at 180°F and good air movement. We don't sell IR ovens but we can put you in touch with people that do. Click [HERE](#) to read our blog on the difference between drying and curing your coatings.

Photo courtesy of Fostoria Process Equipment.

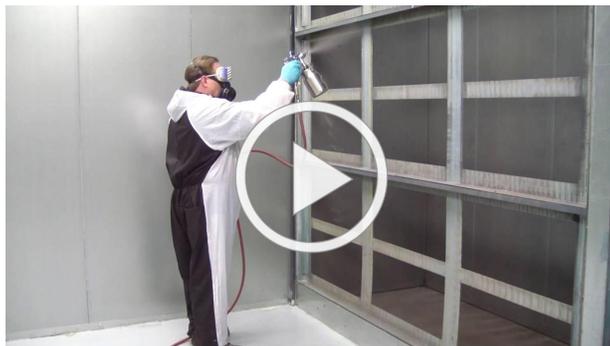
In addition to our bright white Carbicote strippable coatings, one of our featured items is our 945 Crystal Clear. 945 is a window-clear strippable coating that is designed to spray on milky white, but dry crystal clear to protect your lights and windows in your spray booth- anywhere dirt and/or overspray can

attack your investments.
